Office of the Chief Investigator
Transport Safety

**Rail Safety Investigation
Report No 2017/02**

**Collision between truck and tram
At Elliott Avenue, Parkville on
22 May 2017**

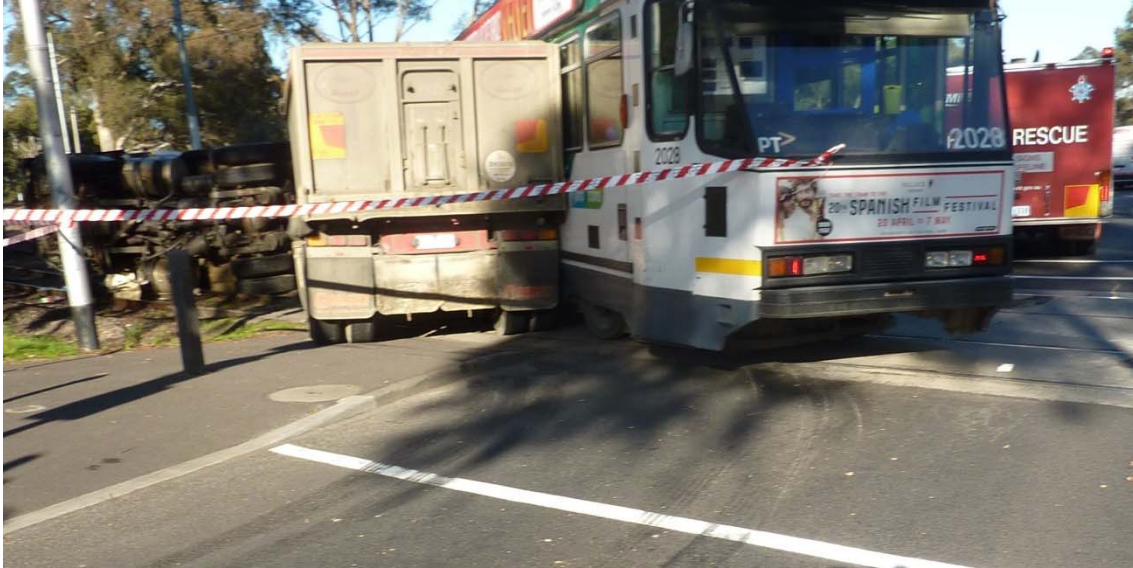
Figure 2: The final location of the truck, its trailer and the tram, viewed from the road approach

The impact derailed the tram such that it fouled the outbound tram track. It remained upright but the truck rolled onto its side, trapping the driver and rupturing its fuel tank. The truck's trailer stayed upright and came to rest along the side of the tram (Figure 2).

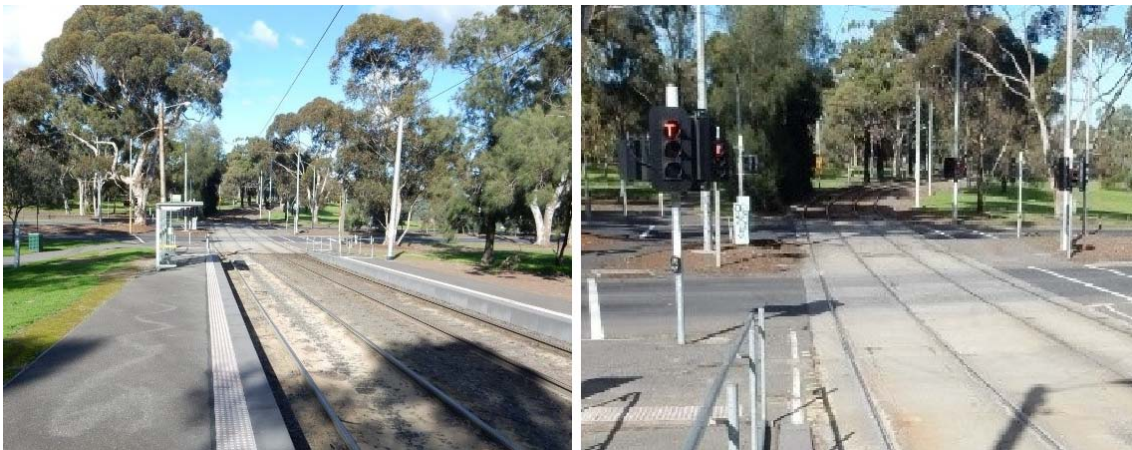
Figure 6: Tram approach to Elliot Avenue from the North - the tram stop (left) and 'T' light (right)

The traffic lights for Melbourne-bound trams was located between the tram Stop platform and the road edge (Figure 6). The 'T' lights were in a vertical configuration with red (top), yellow (middle) and white (bottom).

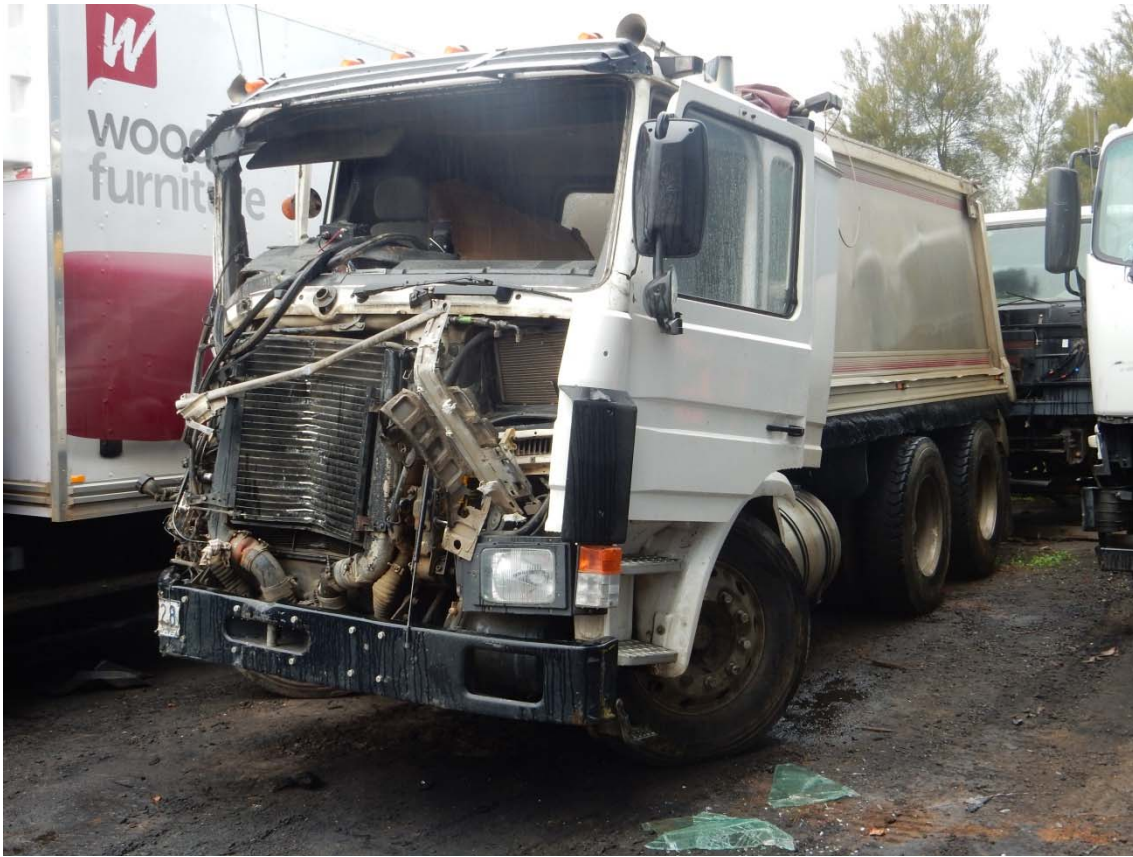
Figure 7: Collision damage to truck

Inspection of the truck identified front-end damage consistent with initial impact on the right-hand leading corner of the truck's driving cab (Figure 7).

The inspection did not identify any aspects of significance excepting that the depth of the tread on some tyres was low.

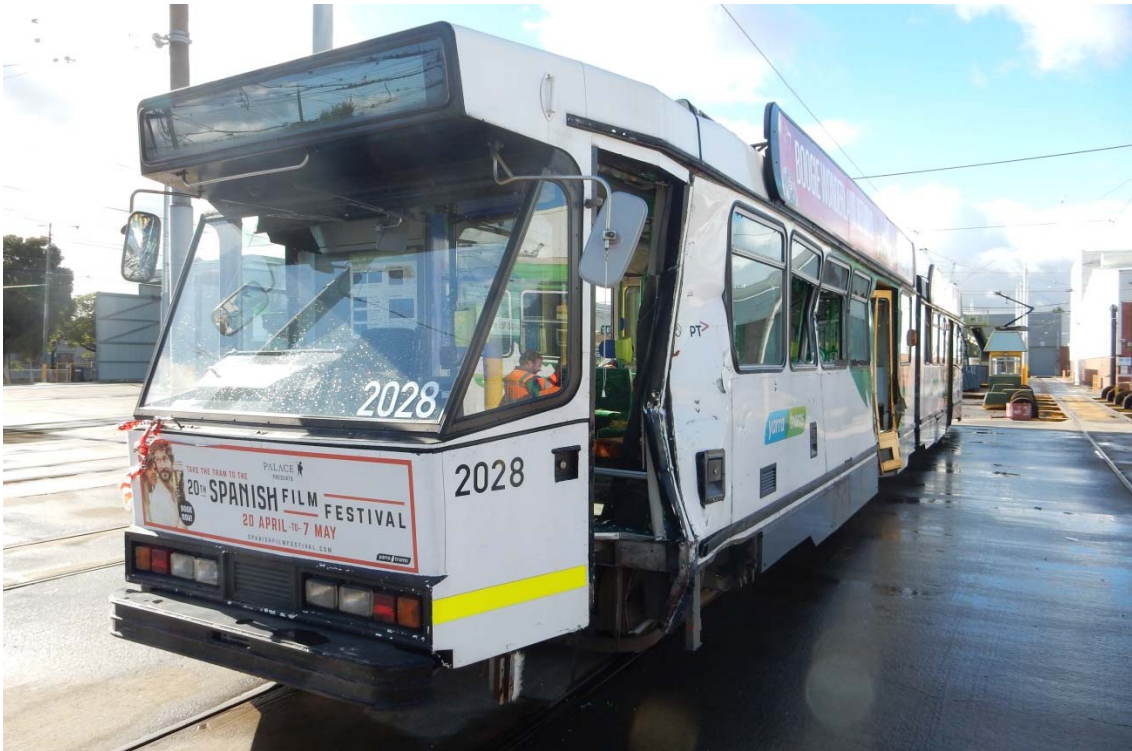
Figure 9: Tram side impact damage, viewed from its leading end

Inspection of the tram identified side damage consistent with impact by the truck (Figure 9). The initial point of impact was probably at the left-side front entry and the more significant damage extended from this door though to the mid entry door near the tram articulation. Rearward of the articulation, damage was lighter and consistent with side-to-side impact with the truck’s trailer.

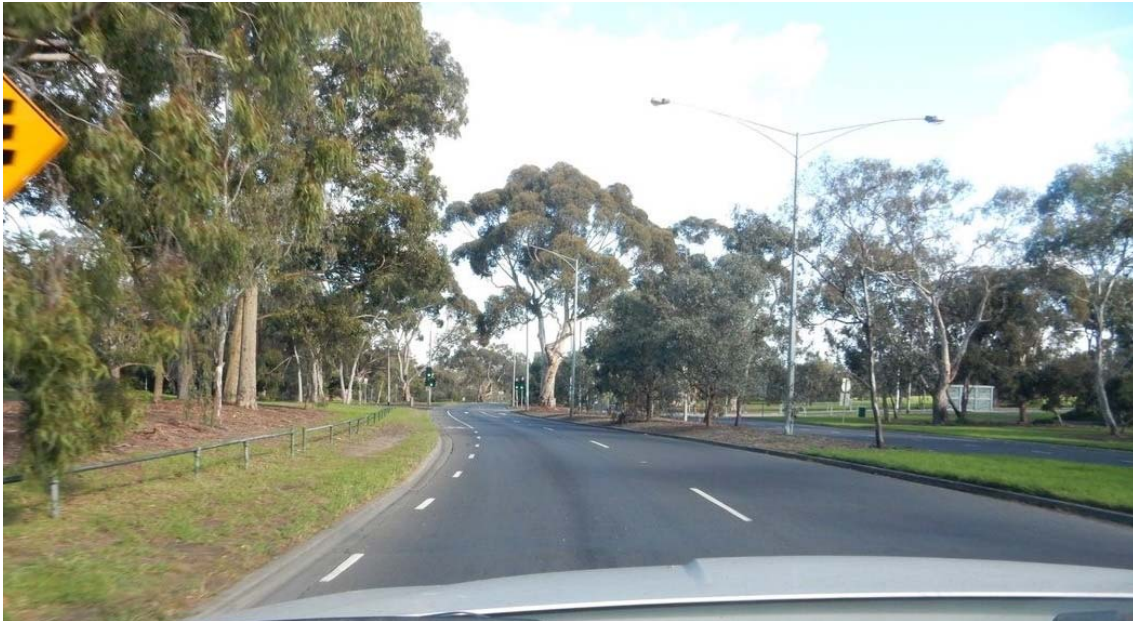
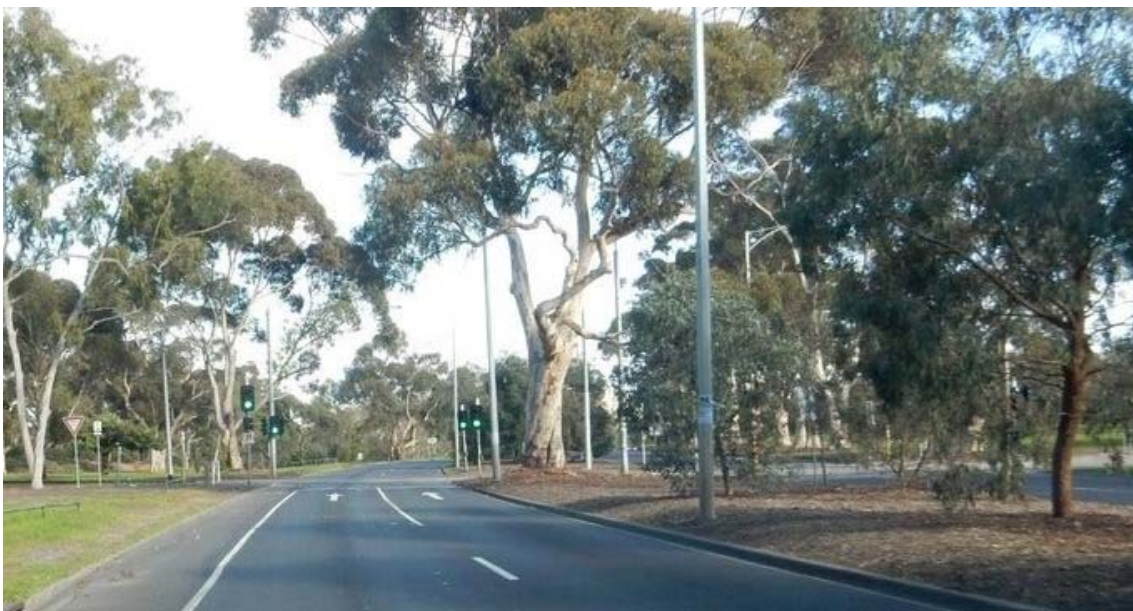
MacArthur Road (that merges into Elliott Avenue) passes through parkland comprising grassland, trees and other vegetation. On the near approach to the road's intersection with the tramway, the median strip was also planted with vegetation of various size. Travelling west, the lower vegetation within the median strip partially restricted the view to the northern side of the crossing and approaching city-bound trams (Figures 11 and 12).

The environment at this intersection, while in keeping with the broader parkland, partially obscured approaching trams and could affect road user behaviours. Particularly for those unfamiliar with this tramway crossing, the parkland environment had the potential to lower road-user expectation of crossing tram traffic when compared to a typical inner city intersection. Vegetation in the median strip also restricted scanning opportunities.

In response to this occurrence, electronic flashing warning signs will be added east of the intersection. In addition, the traffic lights have been modified to increase the time available for trams to clear the intersection.
