Office of the Chief Investigator
Transport Safety

**Rail Safety Investigation
Report No 2017/02**

**Collision between truck and tram
At Elliott Avenue, Parkville on
22 May 2017**

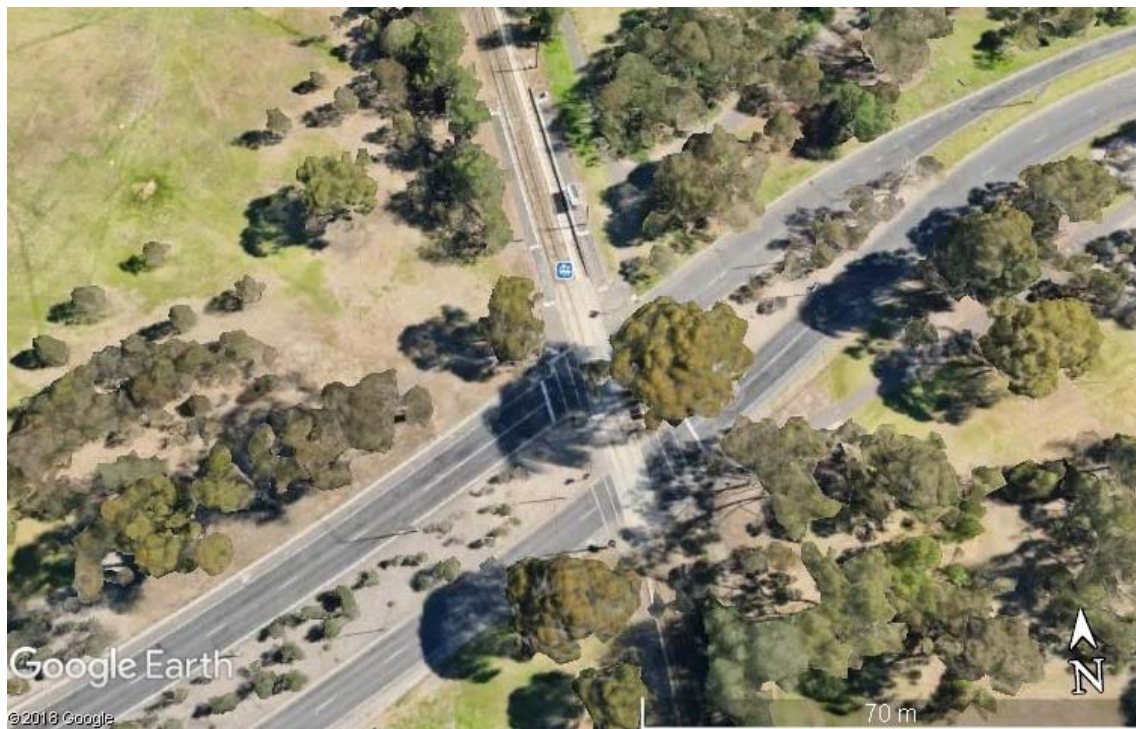
Figure 3: Aerial view of the tramway crossing of Elliott Avenue

The tramway corridor traverses the parkland abutting Elliott Avenue. The surrounding park consists of treed and cleared areas, and the median strip between the carriageways had mixed vegetation including a large eucalypt immediately east of the tram crossing (Figure 3).

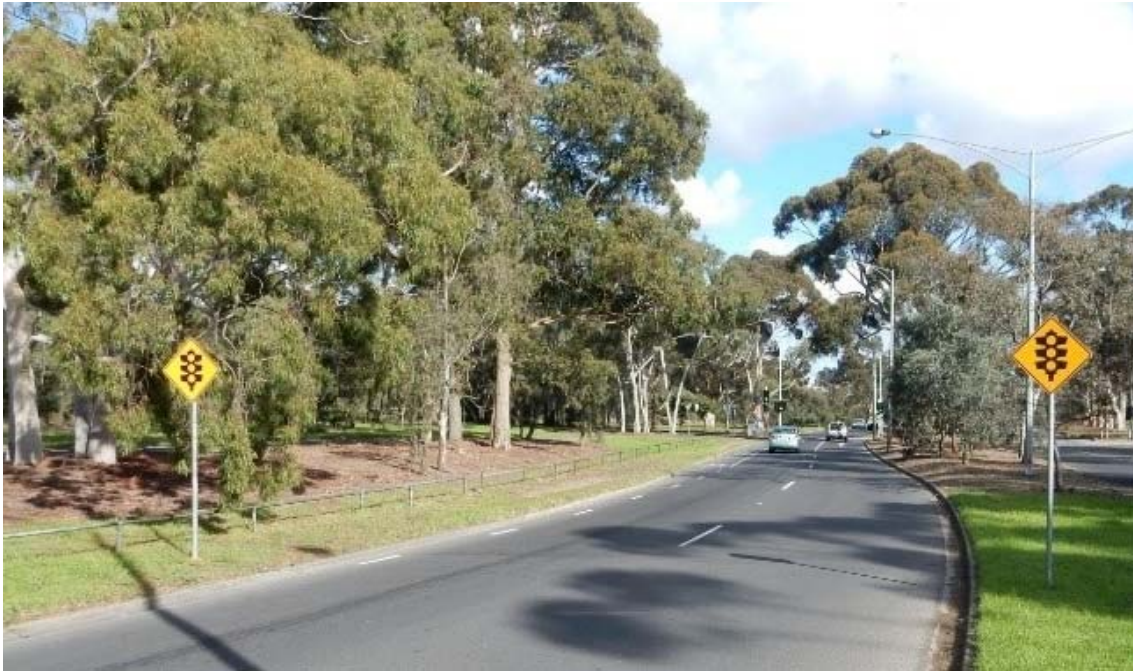
Figure 4: View towards the crossing from the second set of Traffic Lights Ahead signs

Approaching from the east (the truck's approach), a 60 km/h road speed sign was located about 160 m from the intersection. Two sets of *Traffic Lights Ahead* signs were installed on the approach, the first about 210 m ahead of the intersection and the second set 80 m ahead. The traffic lights were visible from this inner set of advanced warning signs (Figure 4).

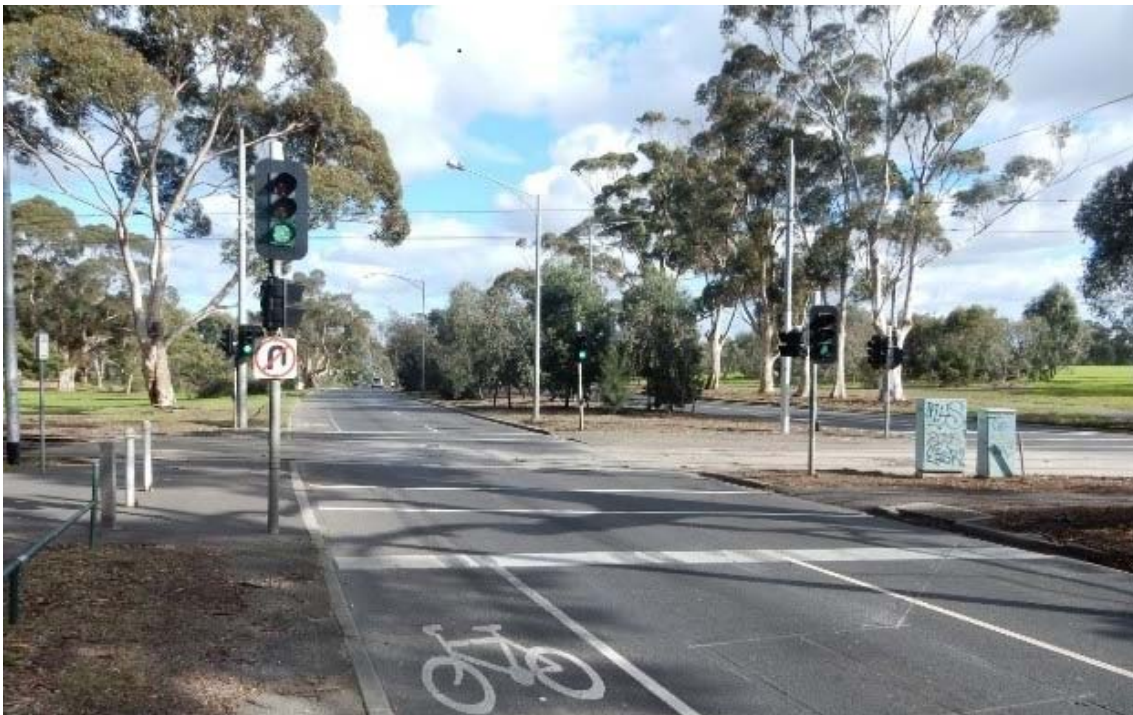
Figure 5: Road traffic lights on the east-to-west carriageway (the carriageway used by the truck).

The tramway crossing at Elliott Avenue was protected by conventional traffic lights (Figure 5). The lights had recently been upgraded to LED (light emitting diode).

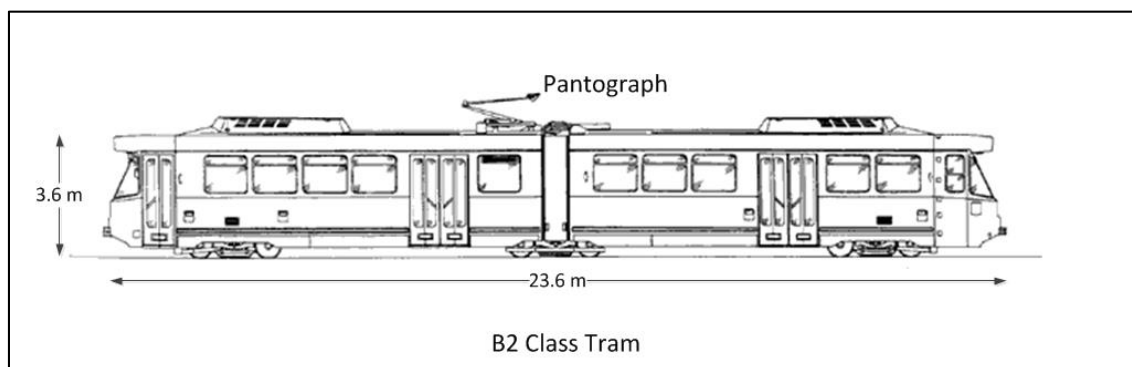
Figure 8: Tram schematic, side view

Tram 2028 was a B2 Class with a capacity of 40 seated and 120 standing passengers and a tare mass of 34 t (Figure 8). There were 132 B2 Class trams built between 1987 and 1994. These trams are not fitted with event loggers.
